## Environmental Science & Assessment, LLC

### MEMORANDUM

RE: Fox Hollow Wetland/Goal 5 Natural Resource Determination  
(18200 SW Horse Tale Drive Washington County, Oregon)

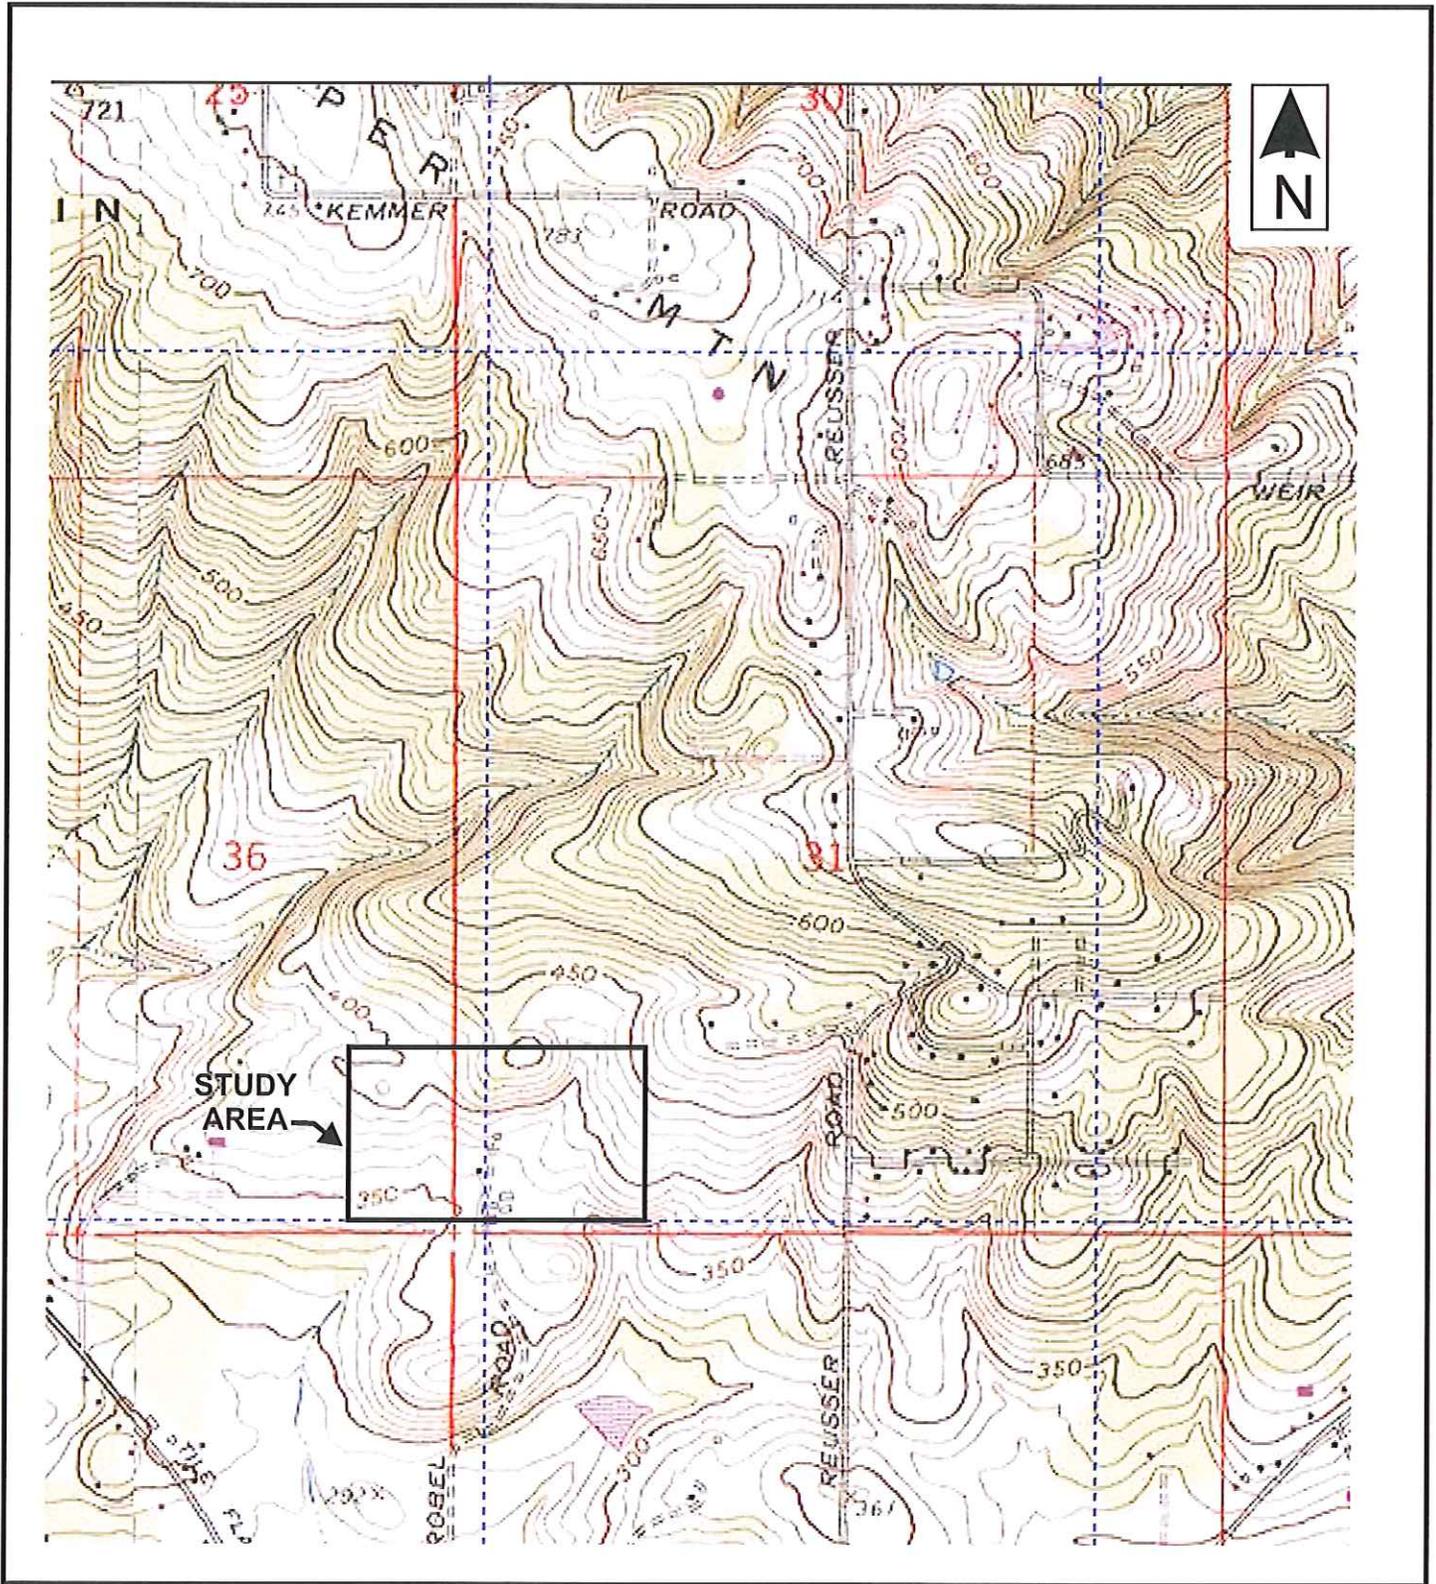
Figure 1

Source: USGS 7.5-Minute Beaverton, OR Quadrangle, 1985. Printed from TOPO! 2000 National Geographic Holdings

Vicinity Map  
MLG - Fox Hollow  
Washington County, Oregon

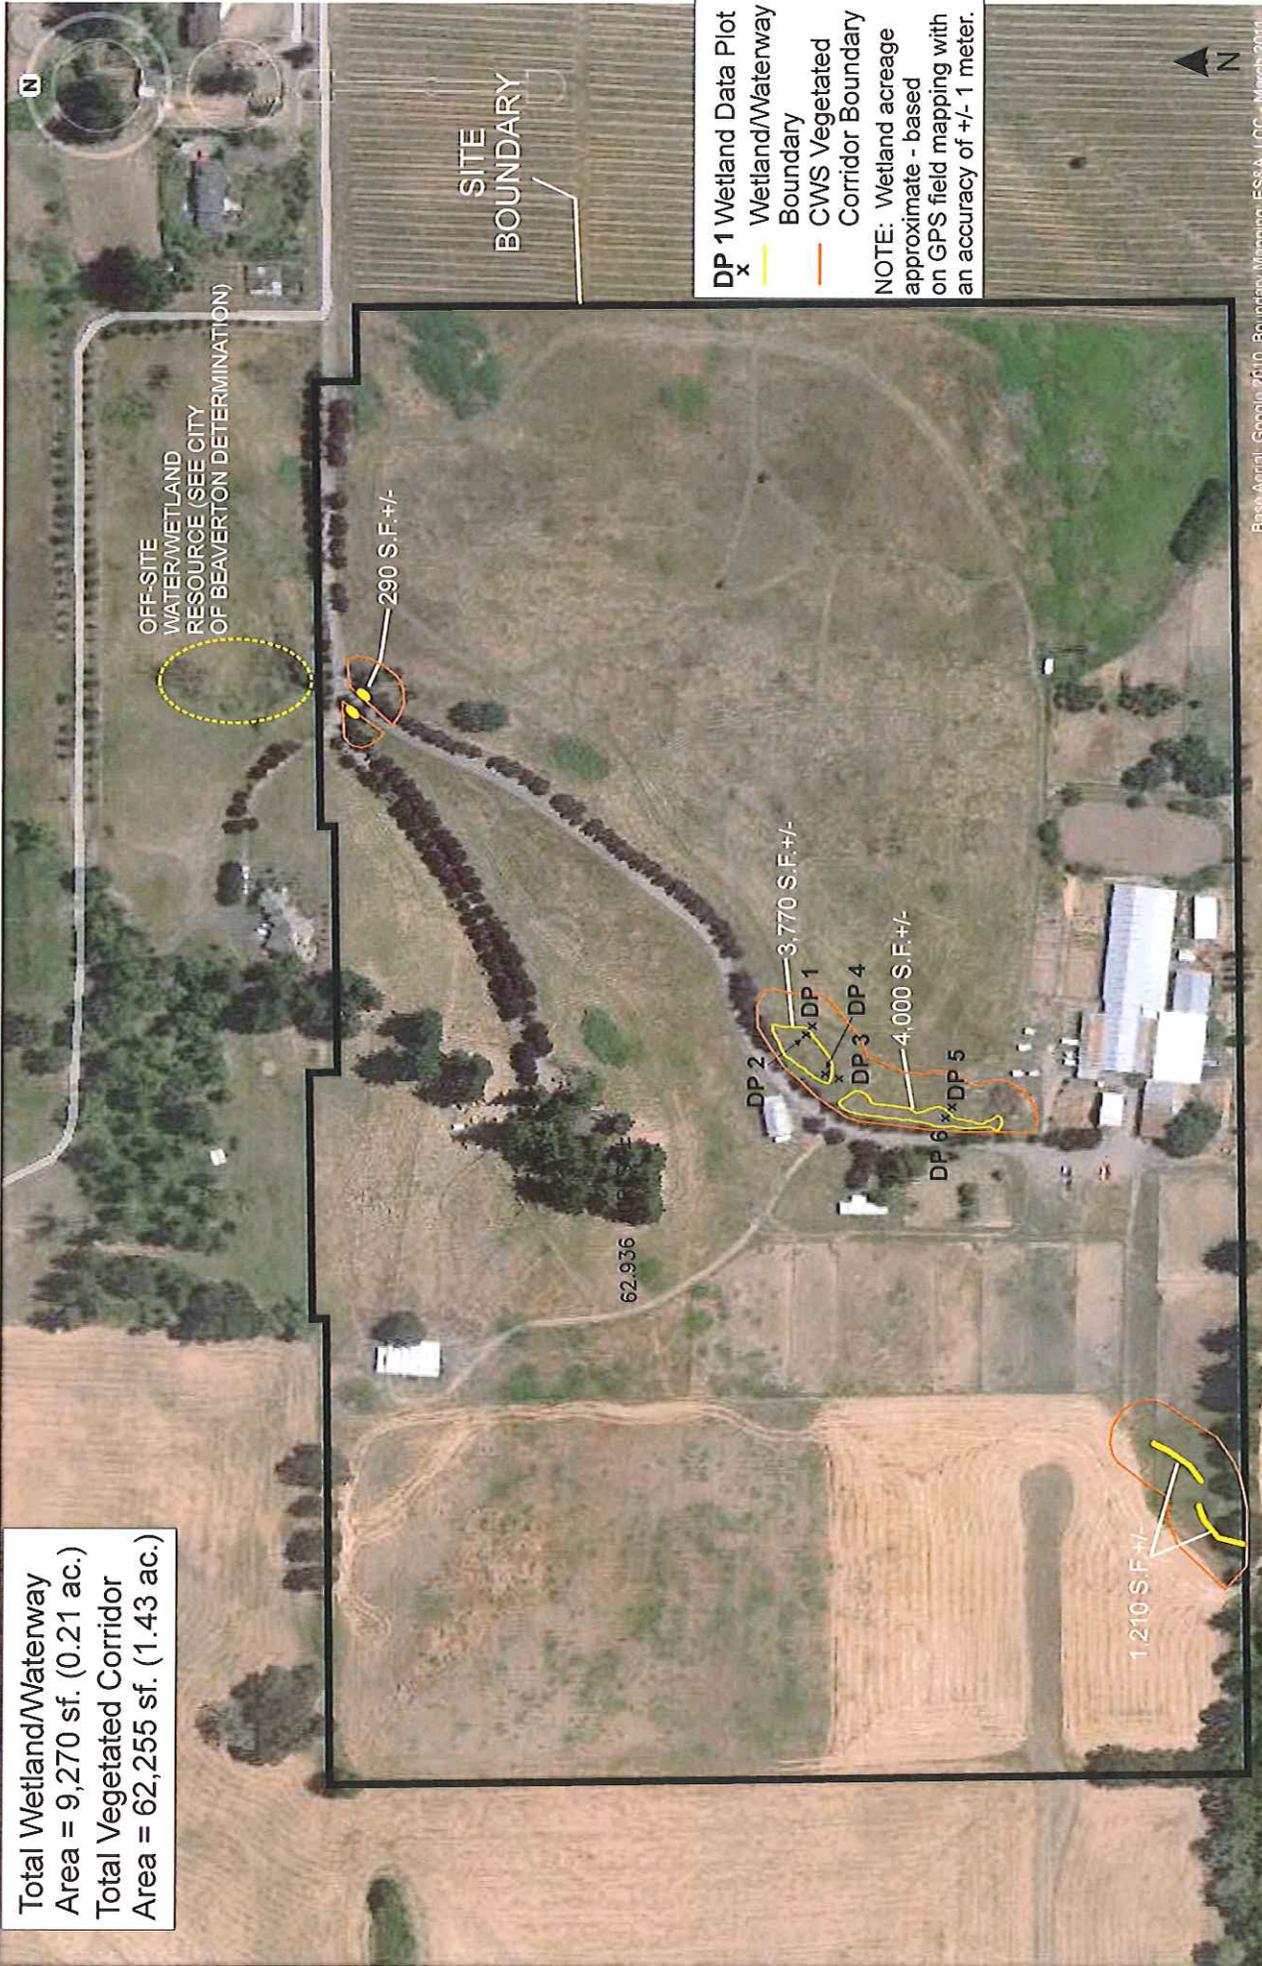
FIGURE 2

Two wetlands and two remnant stream segments were identified on site (Figure 2). Both of the wetlands are located directly east of the entrance driveway at the point where the steeper slopes in the northeastern corner of the site transitions to a more gradual slope in the main open grass field in the interior of the site. The two remnant stream segments are associated with existing culverts and drain tile systems at the north end of the site and the southwest corner of the site.

Total Wetland/Waterway  
Area = 9,270 sf. (0.21 ac.)  
Total Vegetated Corridor  
Area = 62,255 sf. (1.43 ac.)

Wetland Determination  
MLG - Fox Hollow  
Washington County, Oregon

The northern most wetland (3,770 square feet) is located just east of the entrance driveway (Figure 2). Ground water discharging at the base of the road cut collects in a depression extending south and east of the driveway. The emergent wetland is dominated by meadow foxtail, lacking any shrub or forest cover.

The southern-most wetland (4,000 square feet) parallels the driveway just north of the existing boarding facilities (Figure 2). The wetland hydrologic source is ground water discharging at the base of the road cut. This emergent wetland is dominated by meadow foxtail, lacking any shrub or forest cover.

A large culvert located in the southwest corner of the southern wetland that conveys surface water southwest under the horse pastures, east of the barn. The culvert outfalls in the southern stream segment in the southwest corner of the site (Figure 2).
