CLEAN WATER SERVICES  
NATURAL RESOURCE ASSESSMENT  
WEST HILLS DEVELOPMENT:  
SOUTH COOPER MOUNTAIN HEIGHTS PROPERTY

West Hills Development  
735 Southwest 158th Avenue  
Beaverton, Oregon 97006

Anchor QEA, LLC  
6650 Southwest Redwood Lane, Suite 333  
Portland, Oregon 97224

**March 2015**

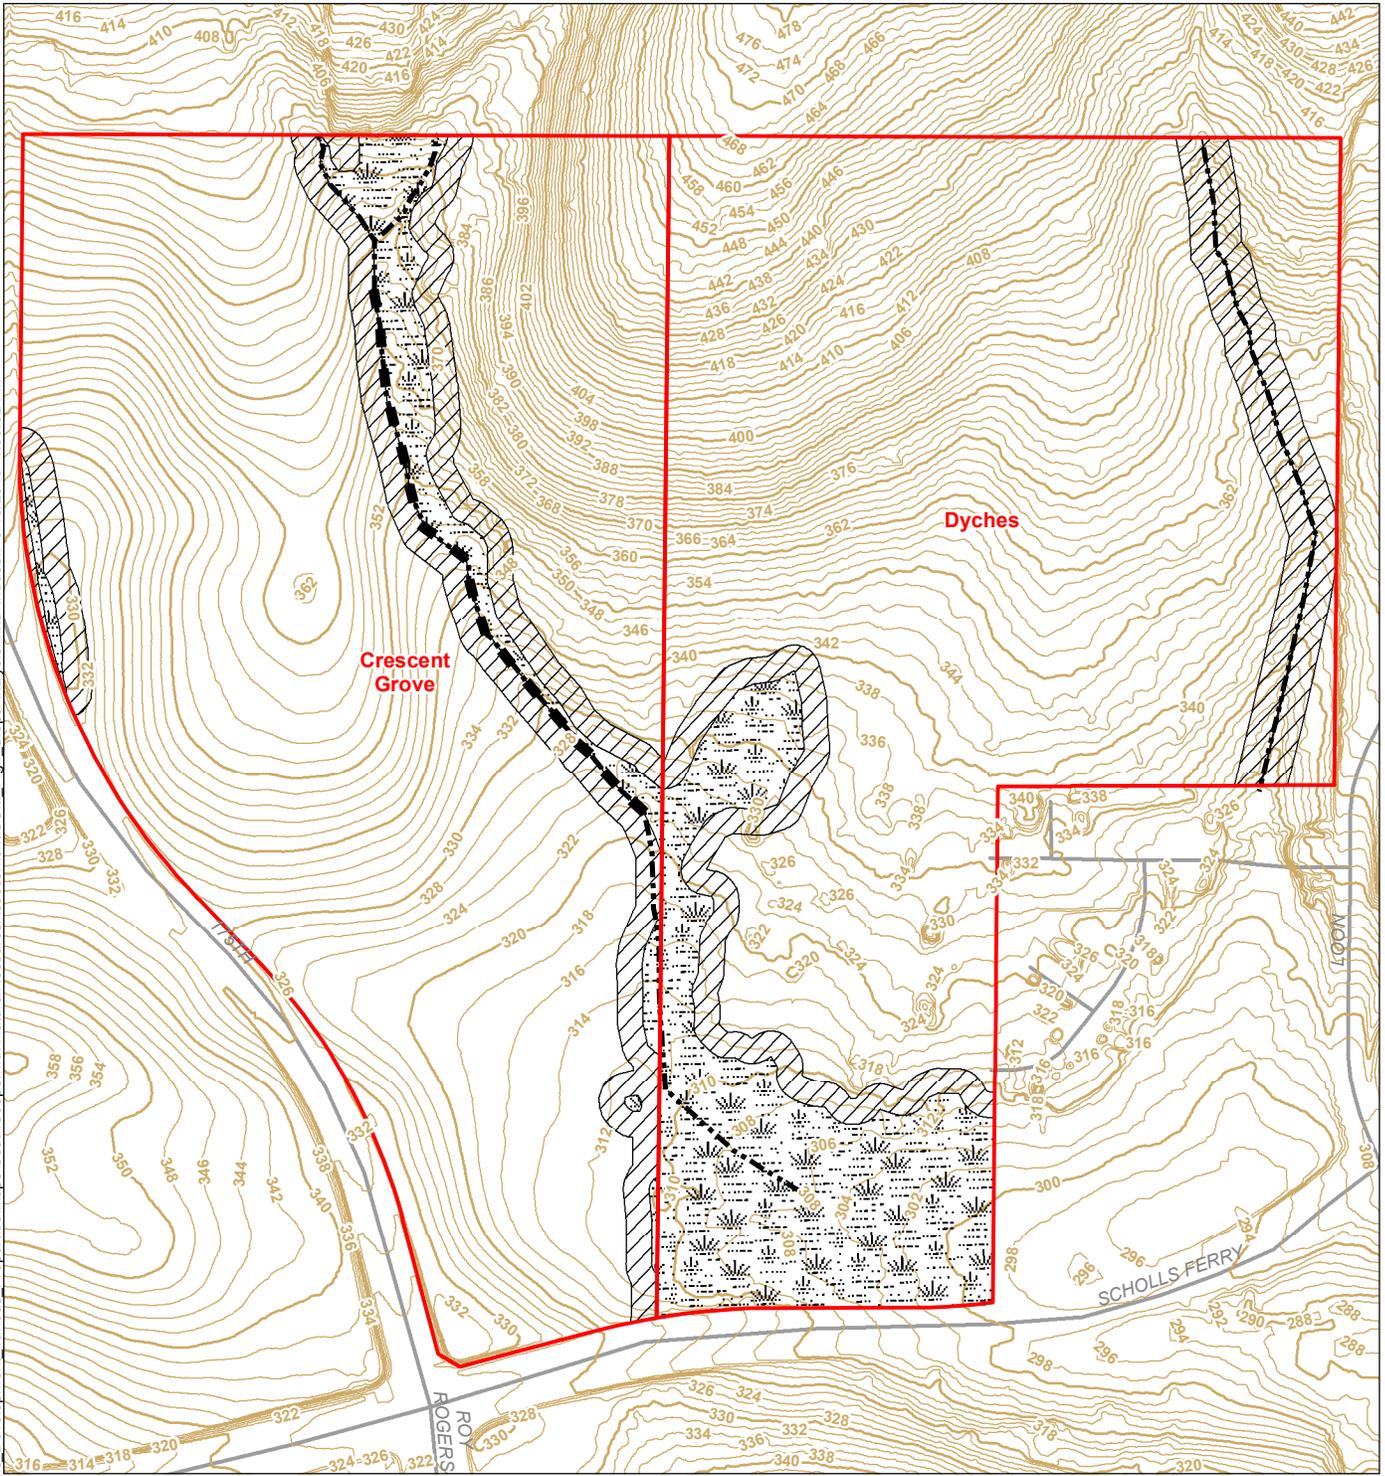
Project Site Boundary	Top of Bank	Delineated Wetland
2-ft Contour	Stream	Vegetated Buffer

- NOTES:**
1. Contours and top of bank data acquired from Otak.
  2. Wetland boundaries and stream flagged and field surveyed by Otak, Inc., to 0.1-meter accuracy. Stream width is 2-ft at top of bank.
  3. Dyches property wetland delineation data acquired from AKS Engineering and Forestry, LLC.

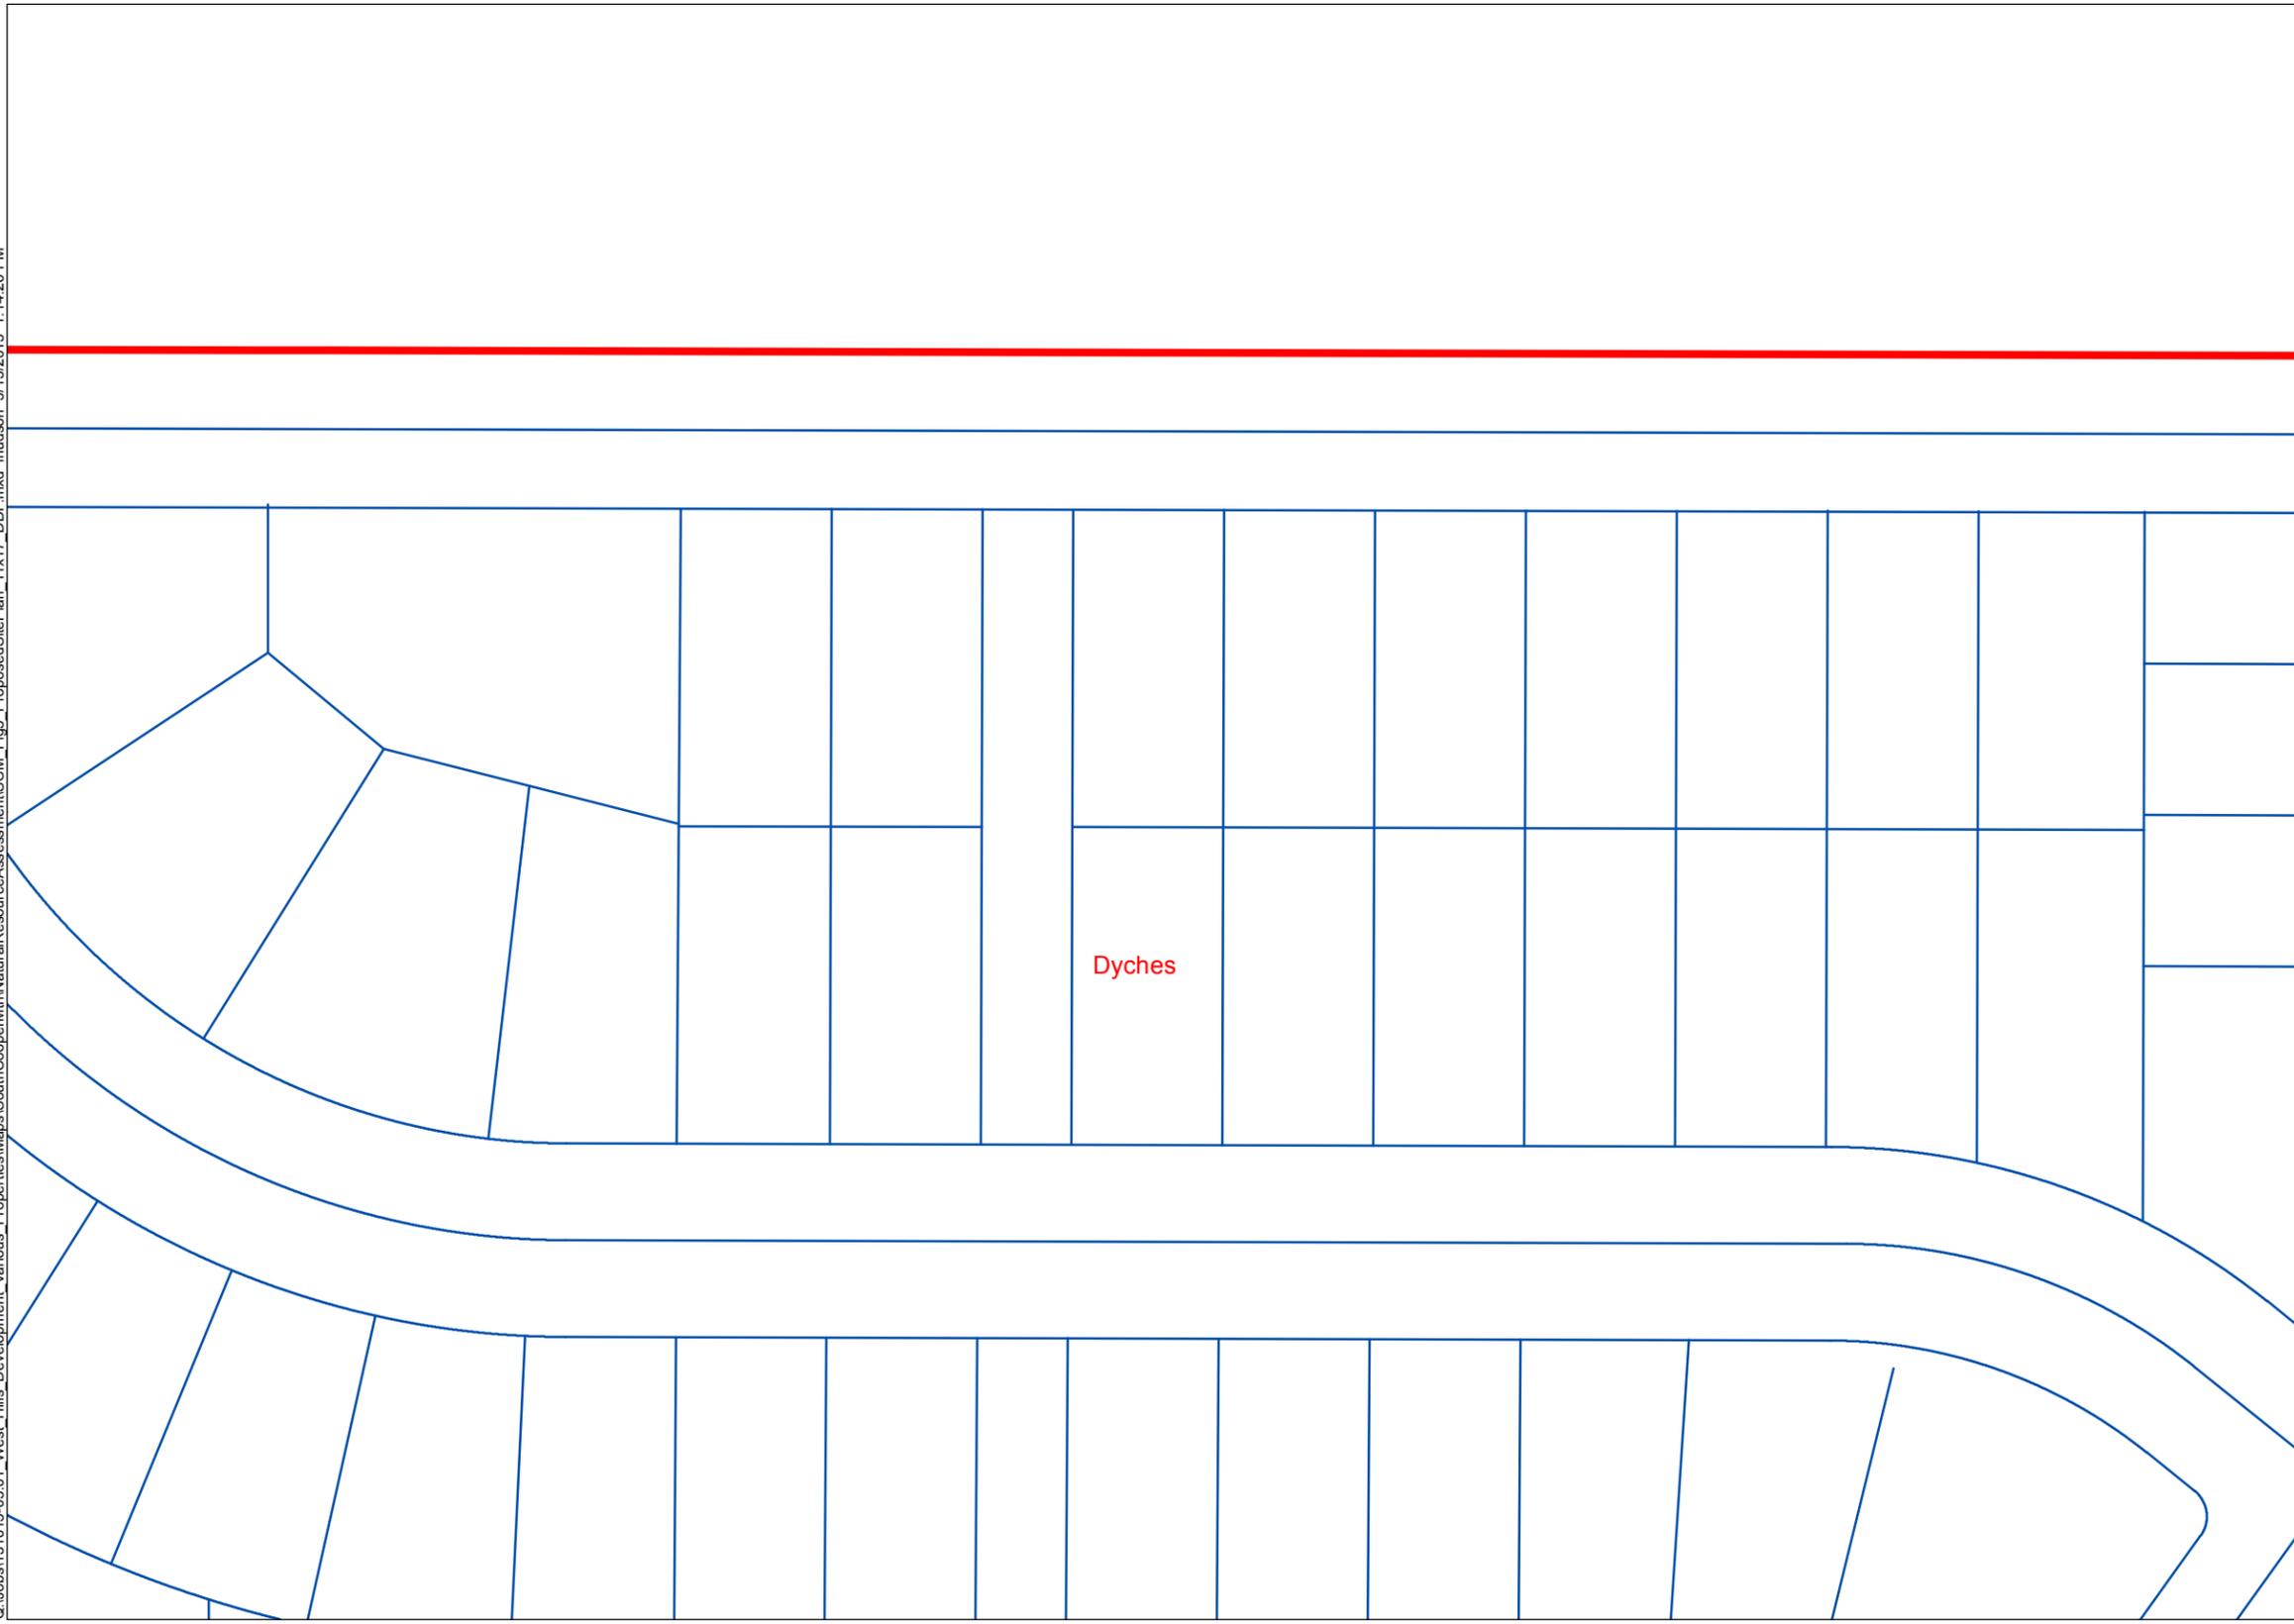
**Figure 5b**  
Proposed Site Plan and Area of Impact  
South Cooper Mountain Heights Natural Resource Assessment  
Washington County, OR

- Project Site Boundary
  - Road
  - Proposed Site Plan
  - Proposed Area of Impact
- Plant Community Condition**
- Degraded

**Plant Community Key:**  
 AD - Agriculture, Degraded  
 FG - Riparian Forest, Good  
 GD - Grassland, Degraded  
 SD - Scrub-Shrub, Degraded

A total of 43,473 square feet (0.998 acre) of vegetated buffer will be impacted during the site development. Impacts are both temporary (2,527 square feet; enhanced through re-planting) and permanent (40,946 square feet; subject to mitigation through on-site creation of additional vegetated buffers or preservation of additional existing areas already in good condition). Temporary impacts are associated with construction activities and will be mitigated by replanting the impacted area to a trajectory to good condition.

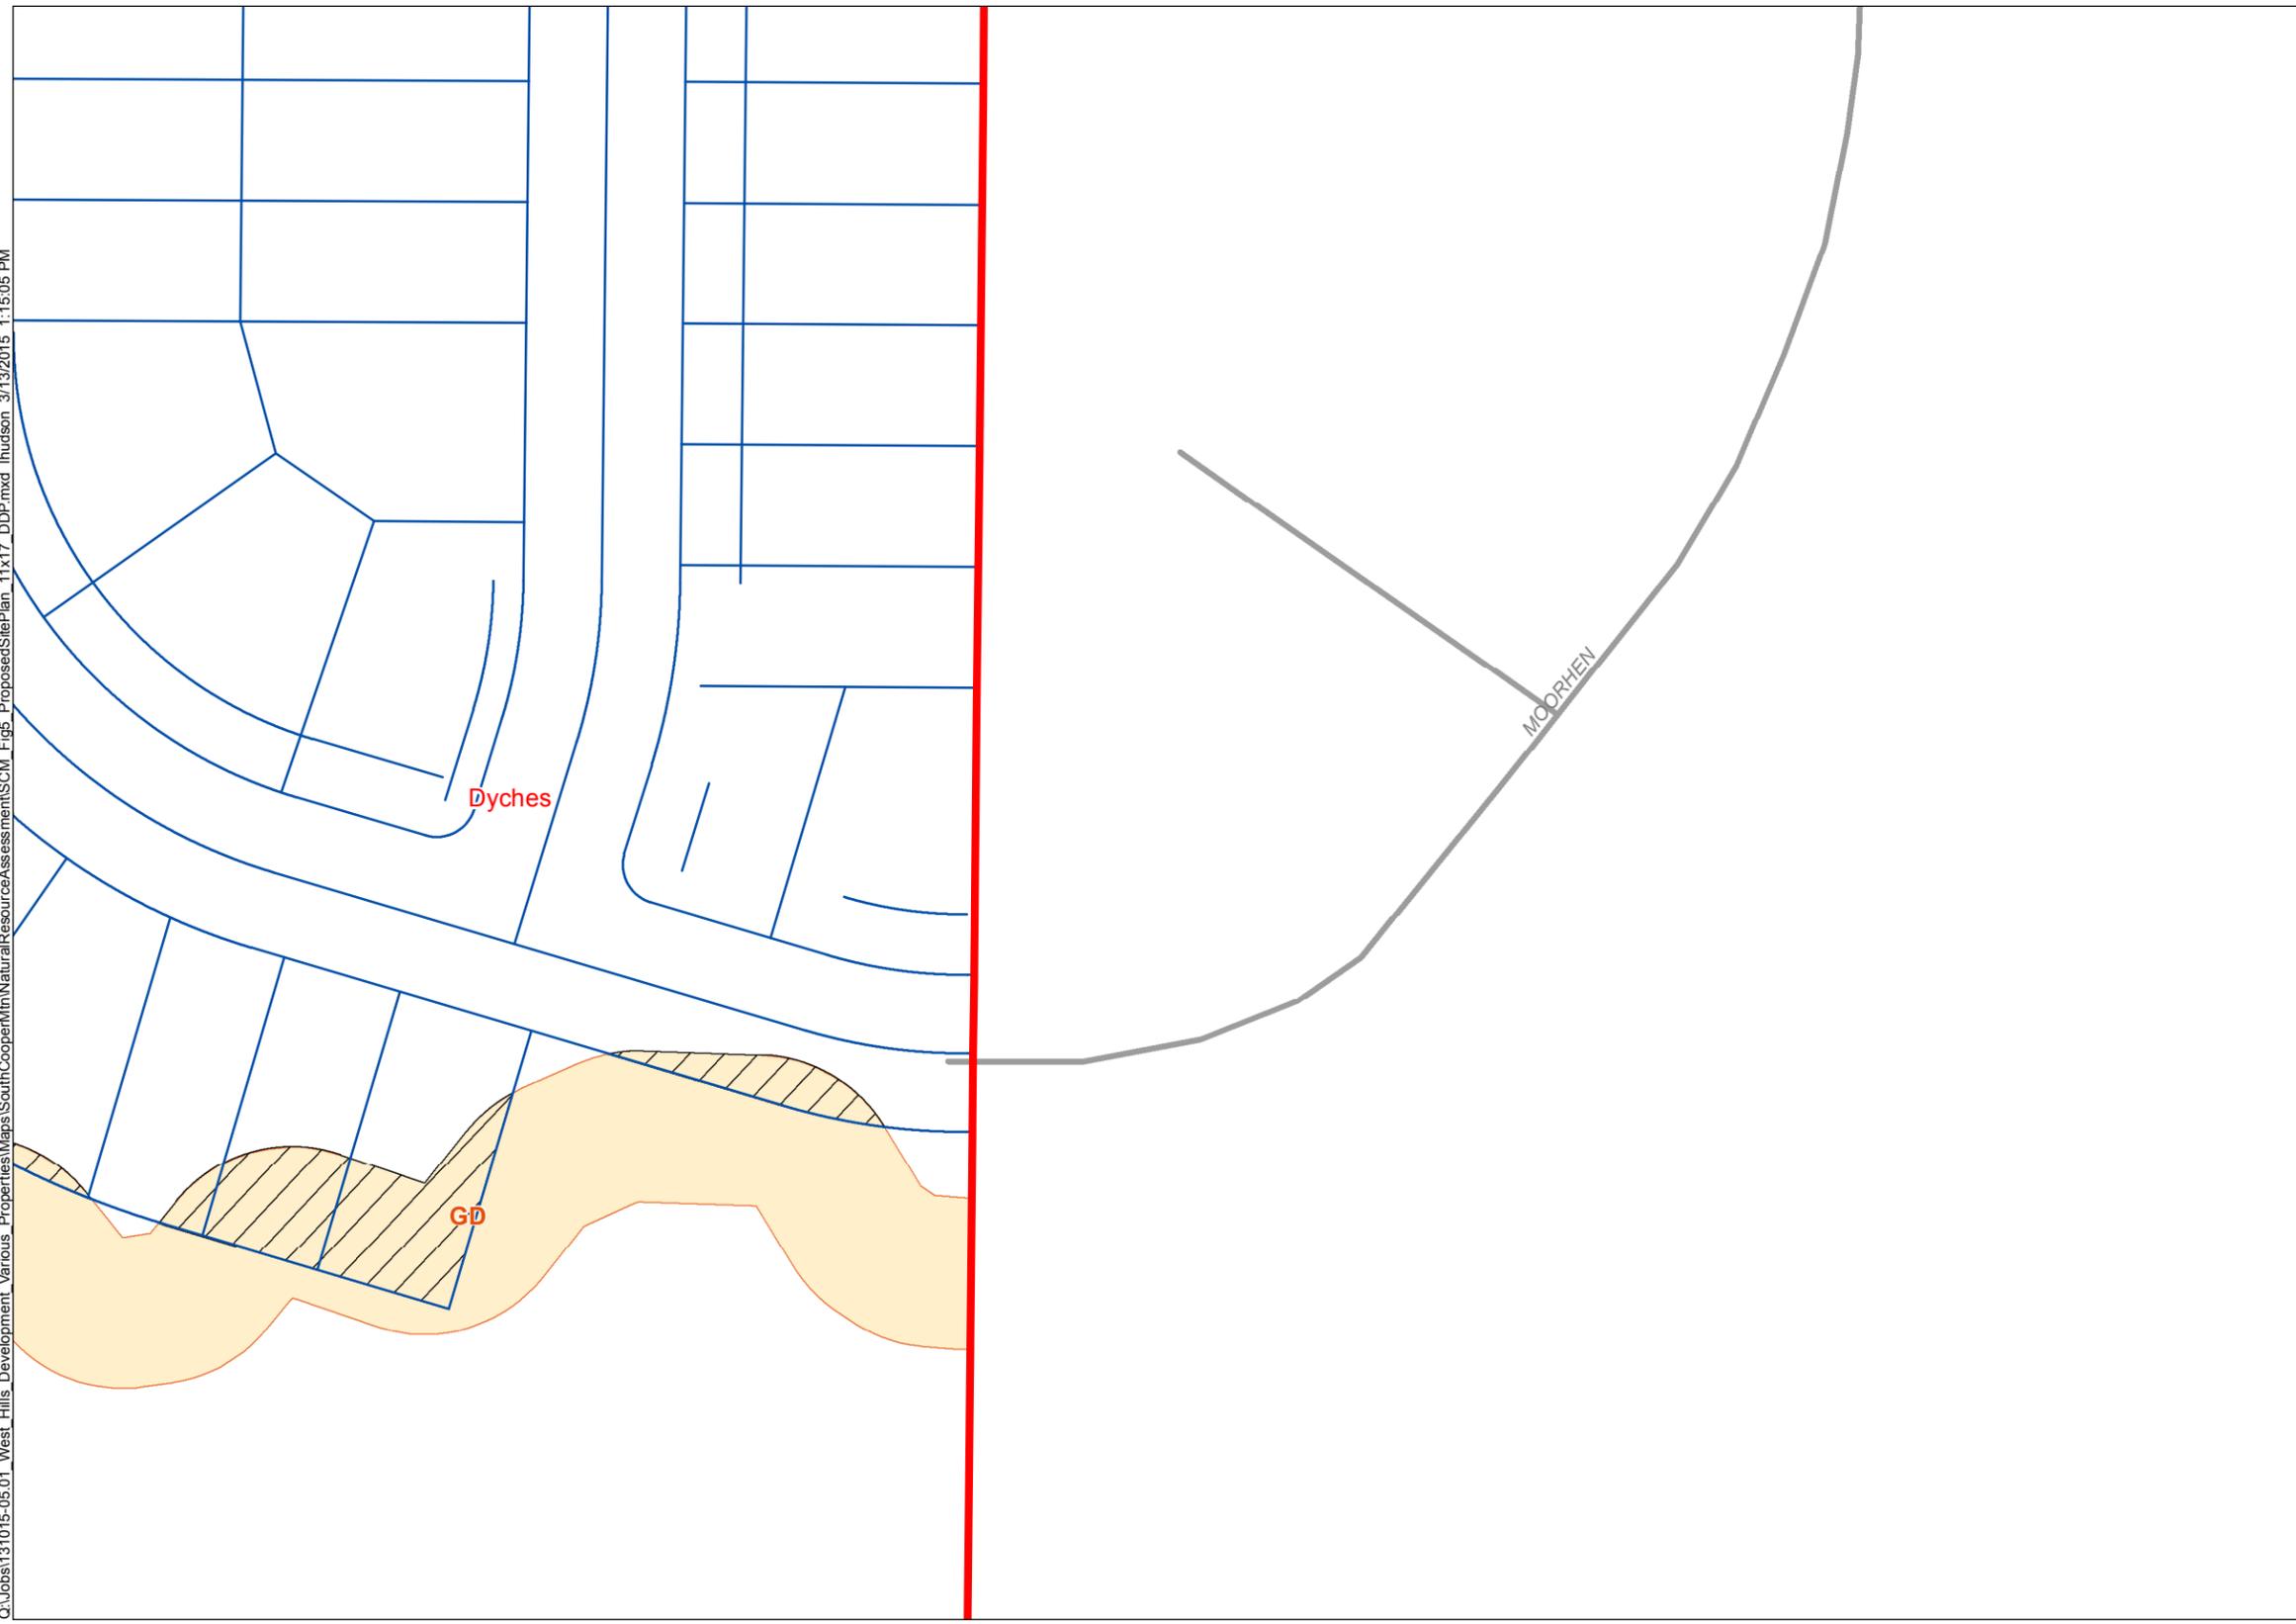
**Figure 5n**  
Proposed Site Plan and Area of Impact  
South Cooper Mountain Heights Natural Resource Assessment  
Washington County, OR

**Project Site Boundary**  
 — Road  
 — Proposed Site Plan  
 ▨ Proposed Area of Impact

**Plant Community Condition**  
 Degraded

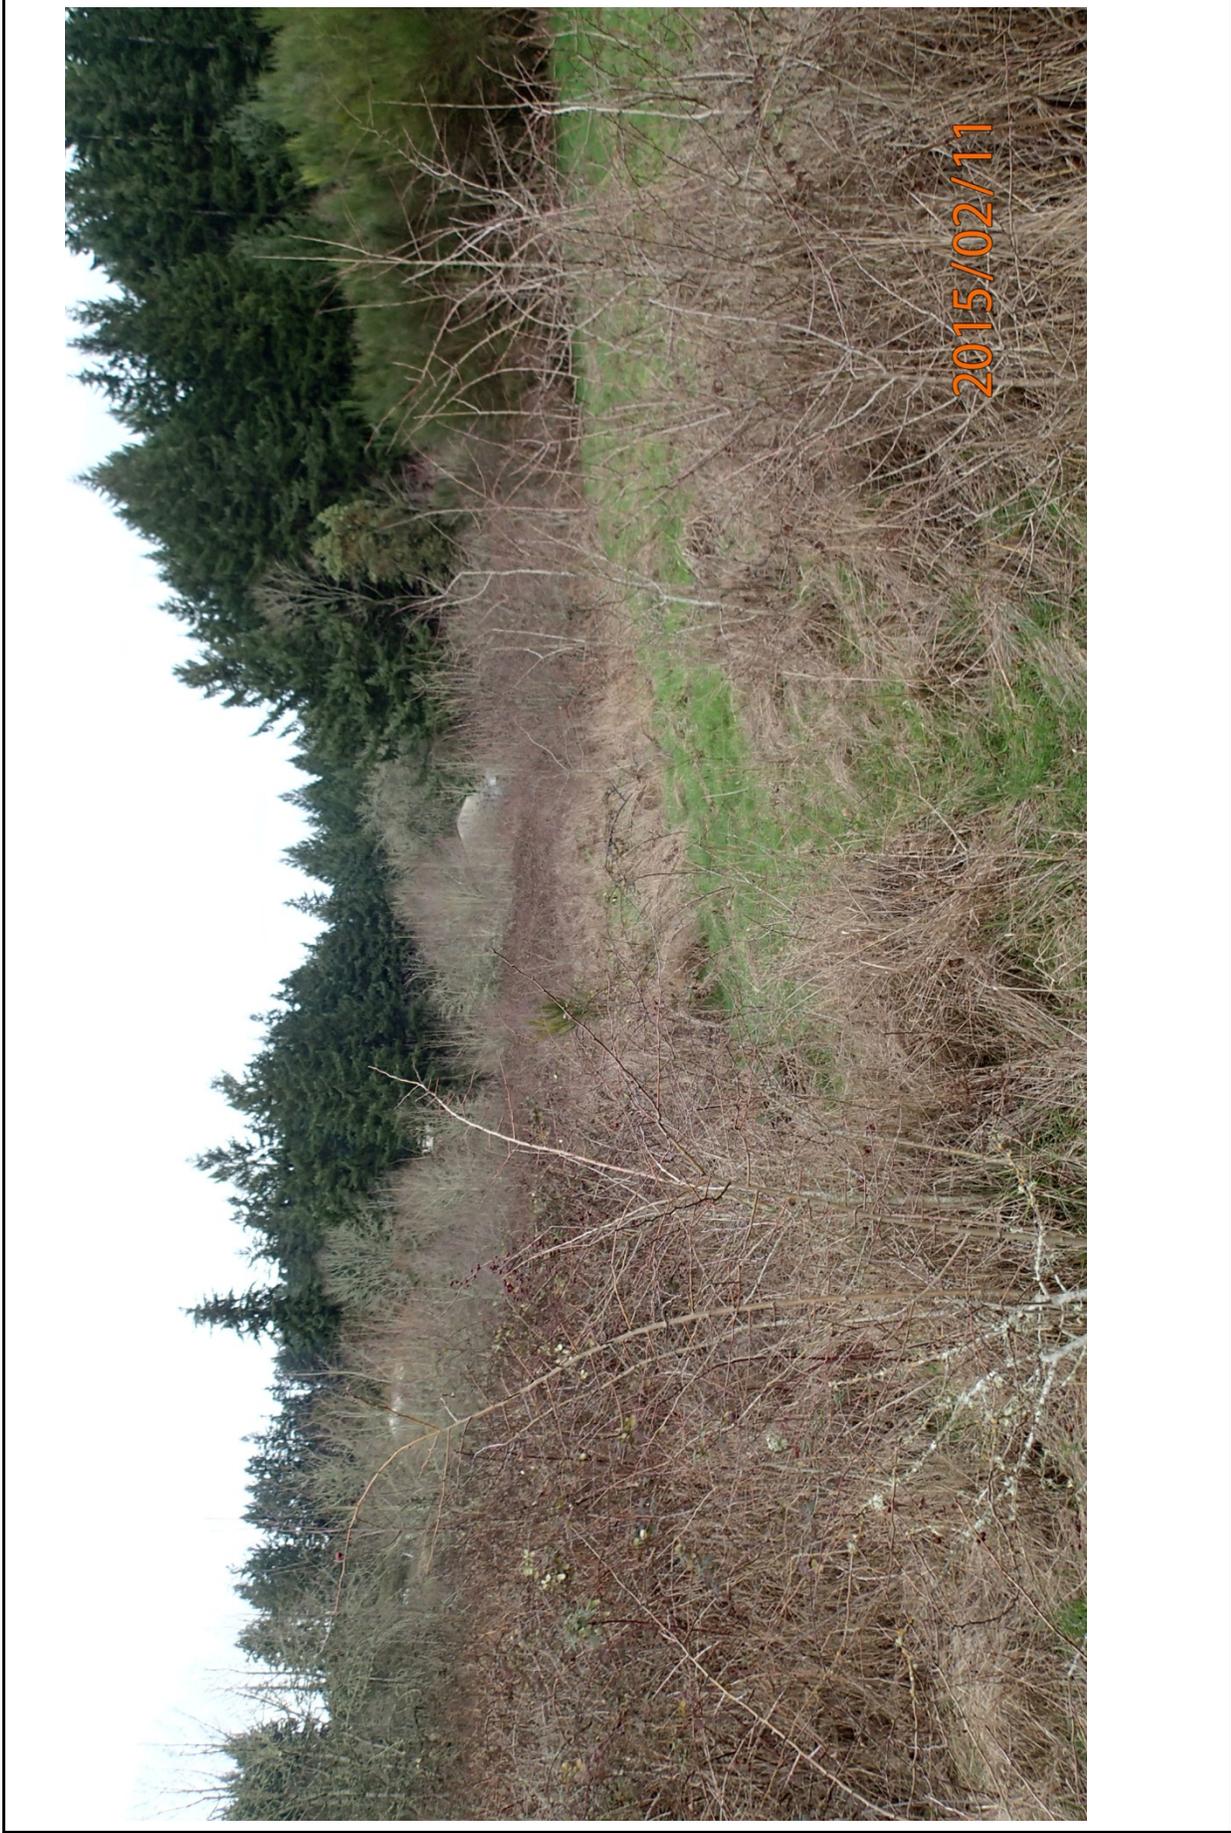
**Appendix D, Photo 9**  
Wetland 1 East Boundary – Shrub-scrub Vegetated Corridor (Degraded Condition)  
Natural Resources Assessment Report  
West Hills Development – South Cooper Mountain Heights

The degraded scrub-shrub plant community follows the eastern boundary of Wetland A. It is dominated by common hawthorn, Himalayan blackberry (*Rubus armeniacus*), Scotch broom (*Cytisus scoparius*), English holly (*Ilex aquifolium*), areas of Oregon ash (*Fraxinus*

*latifolia*), red alder (*Alnus rubra*), and trailing blackberry (*Rubus ursinus*). The herb layer is comprised mainly of poa species and other various graminoids, sword fern (*Polystichum munitum*), Queen Anne's lace (*Daucus carota*), common tansy (*Tanacetum vulgare*), horseweed (*Conyza canadensis*), *Vicia* sp., and other weedy upland plants. The area lacks 25% canopy enclosure but possesses reasonable plant densities in both shrub and herb strata with 100% ground cover. It is rated as degraded due to lack of mature established over story trees and native plant cover. Due to the established plant densities in this area, many plants will be preserved and the area will be infill planted for enhancement.
